# An unconventional approach for retrieval of fractured prosthetic screw: A case report

Joshi A, Kale VT, Suragimath, Zope SA. An Unconventional approach for retrieval of fractured prosthetic screw: A case report. J Osseointegr 2018;10(3):75-78.

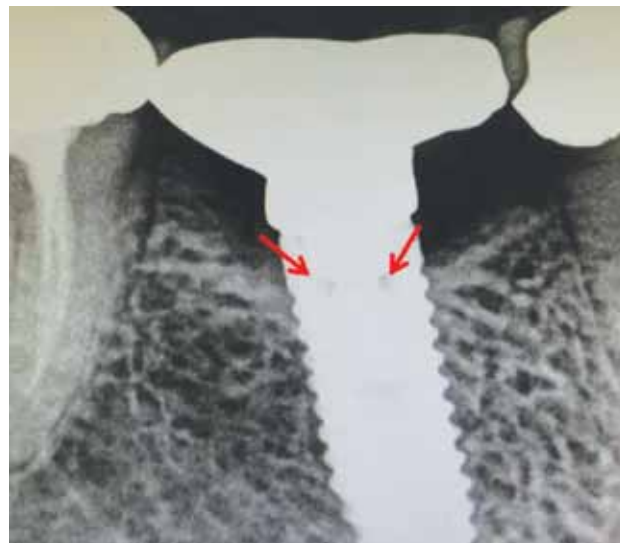
FIG. 2 Improperly seated abutment over the implant along with evidence of marginal bone loss (denoted by arrows).

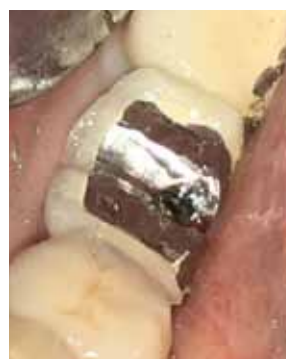
FIG. 2A

FIG. 2 (A) Removal of prosthesis with buccolingual cut. (B) Exposure of fractured prosthetic screw at midpoint.

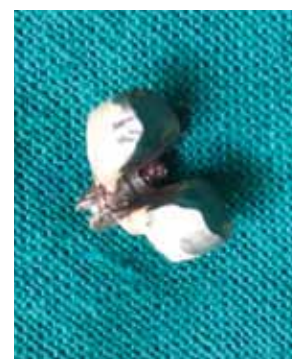
FIG. 2B

The patient noted the mobility of the crown three years back and she reported this to her dentist who had placed the implant previously, but he was unsuccessful in retrieving the prosthesis. The patient reported to our clinic as she had noticed increased mobility during the previous few months. On clinical examination, we observed a mobile prosthesis which was causing discomfort to the patient. On radiographic examination, an improperly seated abutment over the implant was noted along with evidence of marginal bone loss (Fig. 1). A provisional diagnosis of mobile prosthesis associated with an ill-fitting screw was made. After contacting the previous dentist, it was confirmed that the patient had received an MIS M4 implant of 4.2 mm diameter and 11.5 mm length (MIS Implants Technologies Ltd., NJ, USA). It was planned to remove the existing crown followed by placement of a new prosthesis. An informed consent was obtained from the patient prior to the planned procedure. As per the MIS M4 implant specifications, a 1.27 mm hex driver was used to remove the screw. The hex driver did not engage into the screw head through the access hole on repeated attempts. We decided to remove the prosthetic crown by cutting it buccolingually (Fig. 2A). During removal of crown, we discovered that the prosthetic screw was fractured at the midpoint (Fig. 2B).

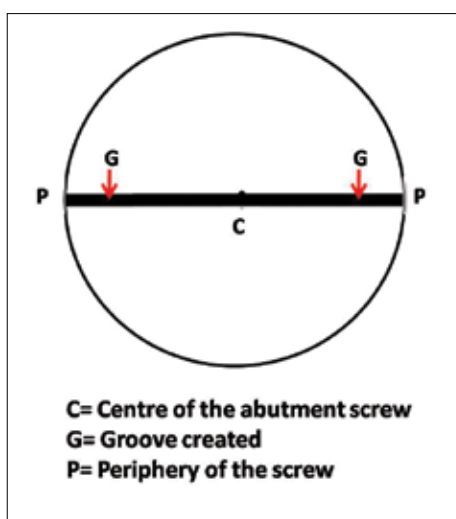
FIG. 3A

FIG. 3 Graphic representation. (A) groove created on the head of the fractured screw. (B) Ultrasonic scaler tip engaged and activated in the groove.

We attempted and failed to retrieve the fractured screw using the technique described by Manpreet et al. (2). We utilised an innovative technique to retrieve the fractured screw which involved making a groove on the occlusal surface of fractured screw across the diameter using a fine round bur no. BR 49 (Mani, Inc, Utsunomiya, Tochigi, Japan) (Fig. 3A). Utmost care was taken not to touch the internal hex geometry of the implant with the bur. An ultrasonic tip F00359 (Acteon group, Stellac, France) was then engaged and activated into the groove at both ends alternatively to loosen it by mechanically

The groove can be created on the broken segment of prosthetic screw with a rotary diamond bur or diamond coated ultrasonic scaler tip. The instrument we select for creating a groove should be smaller than 1 mm as the screw head dimension is 1.2 to 1.27 mm. This is important as we should only create a groove on the screw head without damaging the internal anatomy of the implant. In the current case we used the Mani round bur BR 49 which has a diameter of 0.8 mm.

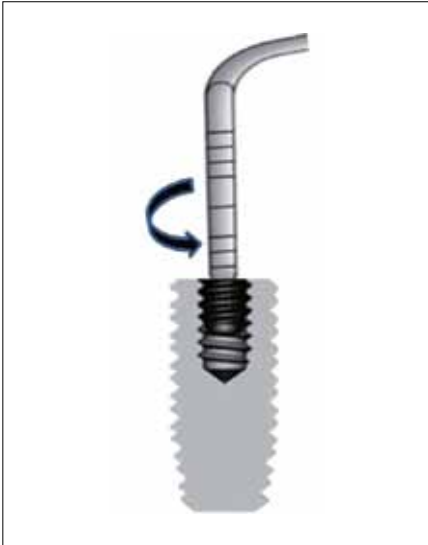
FIG. 4A

FIG. 4 (A) Graphic representation of the Goldman Fox periodontal probe engaged in the groove for screw retrieval. (B) Dimensions of the screw head and working end of the Goldman Fox probe.

moving the tip of the scaler counter clockwise (Fig. 3B). The Goldman Fox periodontal probe (Hu-Friedy Mfg. Co., LLC) was used to engage the notch and the fractured screw was gently driven out of the implant body (Fig. 4A). After the retrieval of the broken part of the abutment screw, a radiograph was taken to confirm its complete removal (Fig. 5A). The new abutment was then tried for the fit and retention which served as an indication to confirm that we did not damage the internal retentive structure of the implant. New abutment and screw were fixed on the implant and the prosthesis was fabricated over it (Fig. 5B).

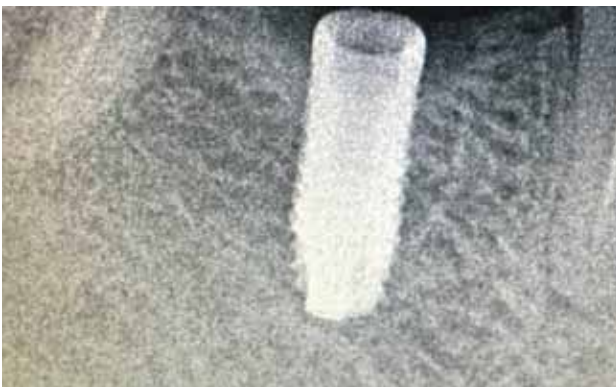
FIG. 5A

FIG. 5 (A) Complete retrieval of the broken part of the abutment screw confirmed with a radiograph. (B) Placement of new screw-retained prosthesis.
