Immediate implant replacement after partial explantation of malpositioned dental implant: Case report and follow-up

Espinoza Espinoza DAK, Guerrero ME, Cáceres La Torre OA. Immediate implant replacement after partial explantation of malpositioned dental implant: Case report and follow-up. *J Osseointegr* 2019;11(4):540-543.

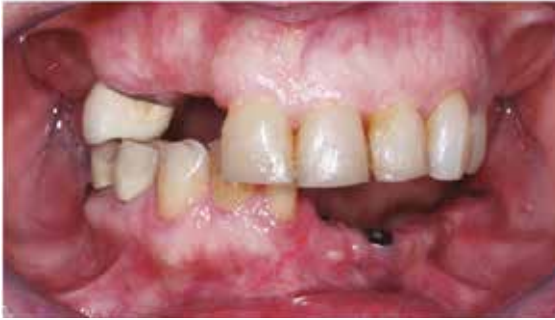
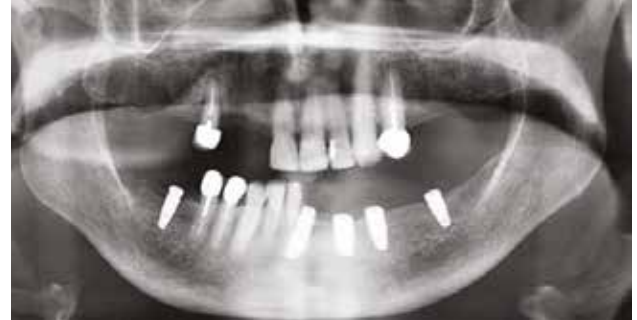
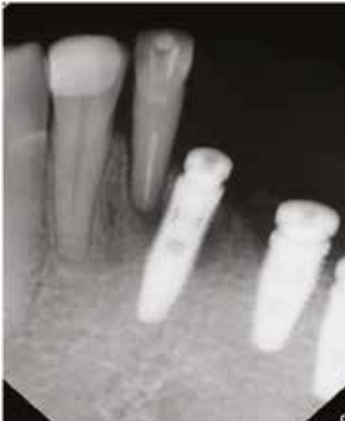
FIG. 1 Patient evaluation: front view of the initial condition (a); digital panoramic radiograph showing five dental implants in the jaw (b); digital periapical radiograph showing a dental implant on position #31 close to tooth #41 (c).

compromising the radicular integrity of tooth #41 which presented mobility (Fig. 1).

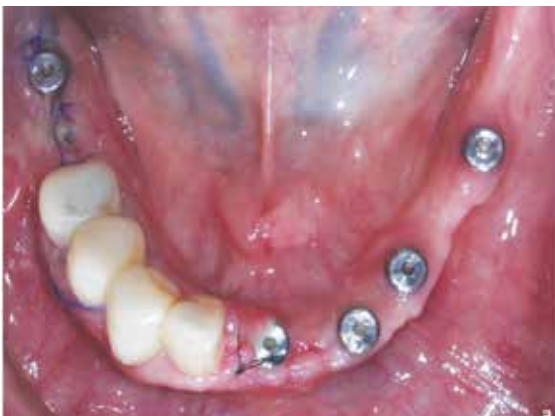
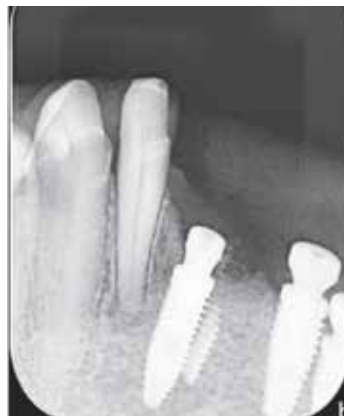
A second stage surgery was performed five months after dental implant placement. A radiographic control showed the proximity between the implant remnant and the placed dental implant (Fig. 2). Three weeks after the second stage surgery a screw-retained fixed partial prosthesis was placed (Fig. 3, 4).

FIG. 2 (a) Occlusal view presenting the healing abutments 2 weeks after the second stage surgery. (b) Digital periapical radiography showing the osseointegrated titanium fragment close to the dental implant on position #31.

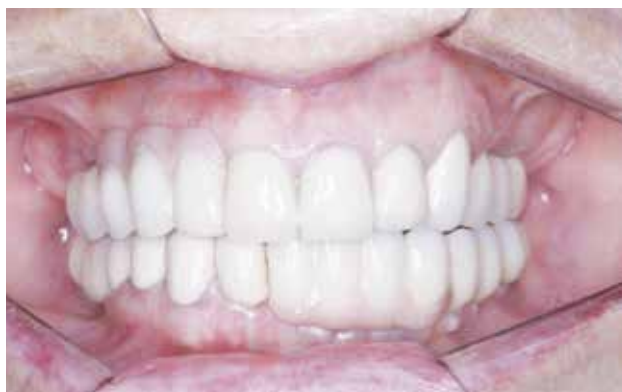
FIG. 3 Front view of final rehabilitation.

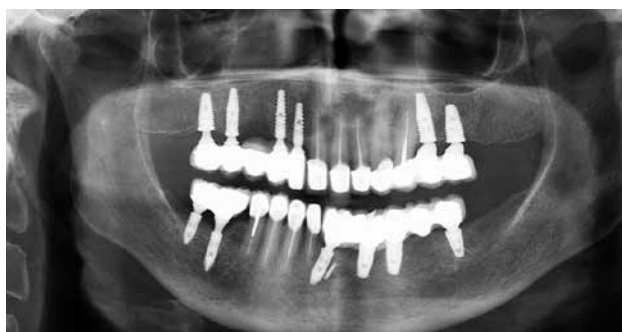
FIG. 4 Digital panoramic radiography after final case rehabilitation.

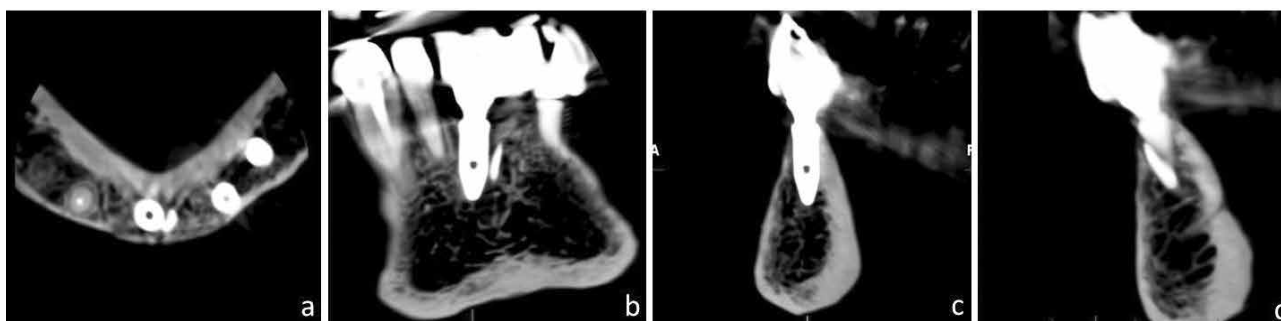
without any sign or symptom of complication. After one year, a cone-beam CT showed no alteration at the bone level (Fig. 5). The patient was instructed to follow maintenance therapy every six months. However, she did not return until after 2 years of function. The clinical evaluation showed marginal inflammation of periodontal and peri-implant soft tissues. No periodontal pockets were found. However, the oral hygiene index increased to 57% (Fig. 6). The radiographic evaluation showed a reduction of the crestal bone level compared to the previous radiographic control of implants 3.1 and 3.3. On the other hand, no signs of alteration at the bone level were

FIG. 5 Six month CBCT control. Axial view showing bone formation around dental implant #31 and the titanium fragment (a). Coronal view of the titanium fragment close to the implant on position #31 surrounded by bone (b). Cross-sectional view of the dental implant #31 surrounded by bone (c). Cross-sectional view showing bone formation around the titanium fragment (d).

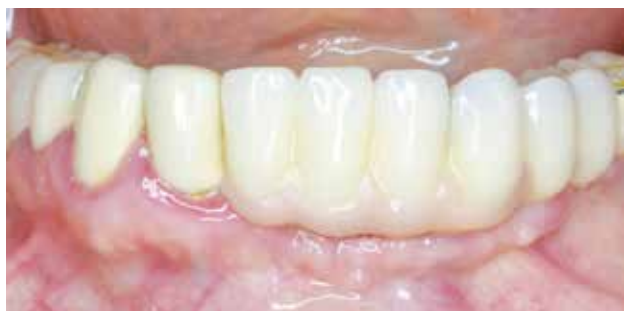
FIG. 6 Clinical aspect after 2 years.

In this case report, no complications during the healing process were reported. However, after 2 years in function and not having attended maintenance therapy regularly, the patient presented soft tissue swelling and crestal bone loss around the implants. This was determined to be associated with bacterial plaque accumulation due to poor hygiene, which is normally observed in patients who are not regular with maintenance therapy.

observed in relation to the contact between the implant and the titanium remnant (Fig. 7). Reinforcement of oral hygiene instruction was indicated with maintenance therapy and regular check-up appointments.

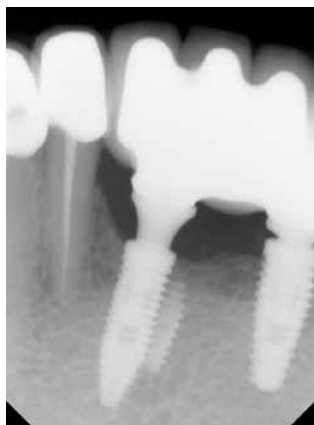
FIG. 7 Periapical radiography after 2 years in function.
